Buccal dehiscence and sinus lift cases

Predictable bone augmentation with synthetic bone material

Authors_ Dr Sérgio Alexandre Gehrke, Brazil & Dr. Giuseppe Maria Famà¹, Italy

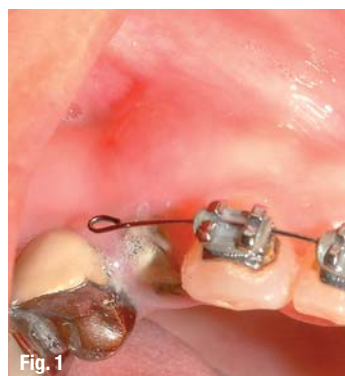
ograph as well as clinically (Fig. 1). The facts that the fracture was old and that a fistula developed around the root resulted in a large loss of the buccal bone wall. The treatment options were presented to the patient, who signed an informed consent form. The patient presented no contra-indications to the treatment.

After administration of the local anesthetics (Scandicaine 2%, Septodont), an intrasulcular incision was made around the root and a lateral one on the buccal side to provide access and allow visualization of the defect. The fractured roots were very carefully extracted to avoid increase of the bone loss. After curettage, the sites were prepared for the installation of the implant according to the manufacturer's instructions. The bone defects were measured with a periodontal probe with millimeter

markings (Figs. 2 & 8). The implants placed were in each case a Straumann RN SP (4.1 mm diameter, 14 mm length). The implants were installed at the level of the crestal bone of the adjacent teeth.

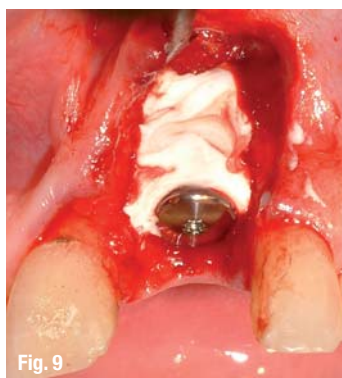
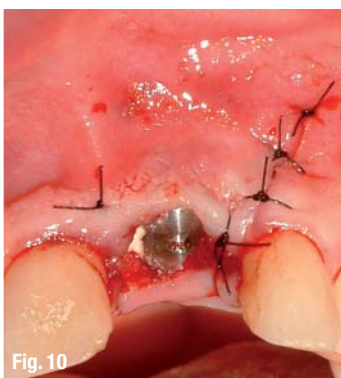
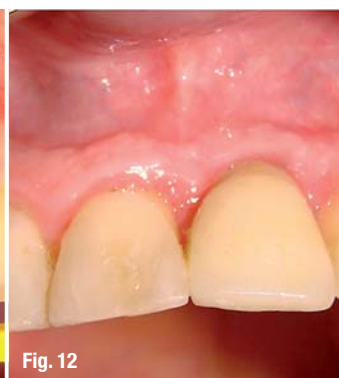
The injection of VitalOs must always be preceded by adequate control of the bleeding with the suction canula. The cement is placed within the defect without need for over-filling (Figs. 3 & 9), unlike what is often done with other types of bone substitutes like granules. Any material put in excess is always expelled or resorbed. With VitalOs, as the cement forms a block, a large quantity or even the whole material may be expelled. When the injected quantity is in large excess, the hardened block can easily break up and large pieces may be expelled out of the site. With granular materials it is only small granules that are expelled and this is less disturbing than pieces of cement. This is the reason why we never overfill sites with VitalOs.

A suture is then made with a 5-0 nylon suturing material. No attempt is made to achieve primary suture over the implant (Figs. 4 & 10) because we observed that even when the cement remains exposed to the oral environment, the bacteriae cannot adhere onto the surface of VitalOs and therefore no infection develops. The implants with a large platform help to maintain the volume and anatomy of the gums because they act as a shape keeper for the gingiva. A post-operative radiograph is taken for each case 7 days after implantation.

The sites were re-opened three months after implant installation to install the healing abutments. Measurement of the buccal bone level was measured again with the periodontal probe (Figs. 5 & 11).

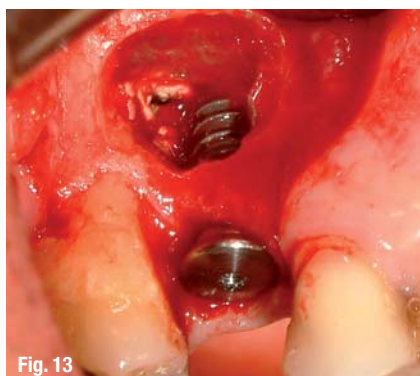
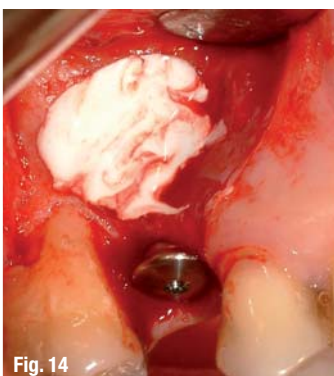
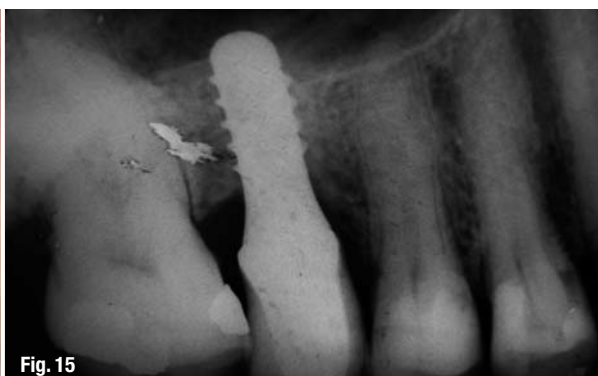
Fig. 16

After local administration of anesthetics (Scandicaine 2%, Septodont) an intrasulcular incision was performed around the root and a lateral incision was made on the buccal side to gain access to the lateral wall of the maxillary sinus. After creation of the lateral window, the sinus membrane was carefully lifted and the site was prepared for implant installation. Then, the cement was injected against the inner (nasal) sinus cavity up to half of its width, and the implant Straumann RN SP (4.1 mm diameter, 12 mm length) was then installed (Fig. 13). Once the implant installed, the rest of the sinus cavity was filled with the cement (Figs. 14 & 16). The suture was made with 5-0 nylon simple
